# Anonymized drying report

A polished example of how drying progress, equipment decisions and completion can be documented without exposing customer, property, claim or insurer information.

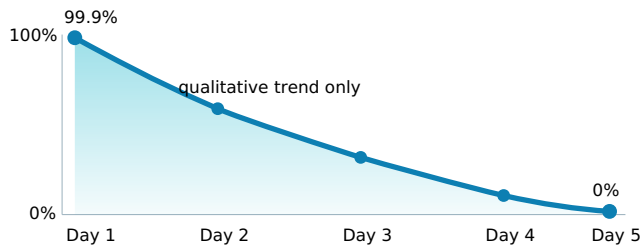
## Five-day moisture trend

**Chart integrity:** exact public endpoints are labelled. The connecting curve communicates the published direction of travel; it is not a claim of unpublished daily percentages.

| Day | Published status | Action / decision |
|---|---|---|
| 1 | Initial reading: <b>99.9%</b> | Water extracted; areas cleaned and sanitised. Installed 8 blowers and 2 dehumidifiers. |
| 5 | Final reading: <b>0%</b> across Zones A–C.<br><b>GOAL REACHED</b> | Removed the remaining 5 blowers and 1 dehumidifier; area handed back for operational use. |
